The purpose of this form is to cover the higher percentage problems and repair procedures of TEVs in supermarket applications.

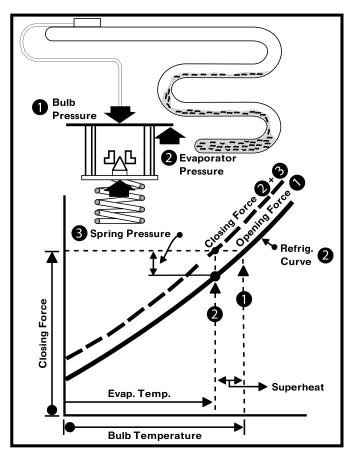
A brief review of basic TEV operation is in order. The diaphragm is the actuating member of the TEV. There are three fundamental pressures act-

ing on it: Sensing bulb pressure **P1**, equalizer pressure P2, and the equivalent spring pressure P3. The sensing bulb pressure is a function of temperature and acts on the top of the diaphragm causing the TEV to move in a opening direction. The equalizer and spring pressure act together underneath the diaphragm causing the valve to move in a closed position. Under normal operation (disregarding the pressure differential required across the diaphragm to move it), sensing bulb pressure equals equalizer pressure plus spring pressure, i.e. P1 = P2 + P3. It is important to note that spring pressure is essentially constant once the valve is set. As a result, the TEV is actually controlling the difference between the bulb and the equalizer pressures, which is the amount of the spring pressure. The spring pressure represents the superheat the valve is controlling at the bulb location. Now with TEV basics aside, lets review some of the higher percentage TEV problems when servicing a supermarket. The subject valves had previously been operating at the correct superheat setting.

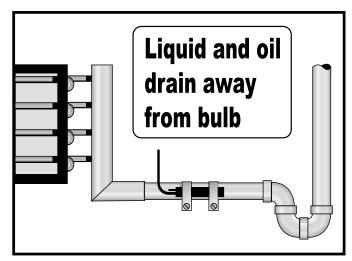
The sensing bulb should be securely fastened to a clean, horizontal section of the suction line at the evaporator outlet.

2 — Check the Sensing Bulb Location: The sensing bulb should be securely fastened to a clean, straight section of the suction line. The bulb should not be influenced by ambient air temperature. The bulb should be attached to a horizontal suction line at the evaporator outlet. If the bulb cannot be located in this manner it may be located on a descending vertical line only. On suction lines 7/8" and larger, it should be installed at 4 or 8 o'clock on the

side of the horizontal line. On smaller lines the bulb may be mounted at any point around the circumference except the bottom of the line where oil may influence the sensitivity. On multiple evaporators, the piping should be arranged so that the flow from any one valve cannot affect the sensing bulb of another. The equalizer connection should be made at a point several inches downstream of the bulb.

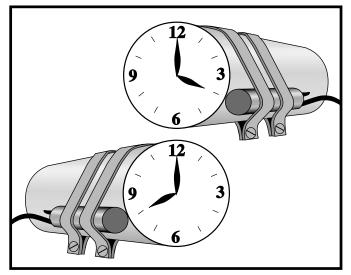
On suction lines 7/8" and larger, the sensing bulb should be installed at 4 or 8 o'clock on the side of the horizontal line.
